United States
Circuit Court of Appeals
For the Ninth Circuit.

UNITED STATES OF AMERICA,
Appellant,

J. LESLIE MORRIS COMPANY, INC., a cor-
poration,
Appellee.

Transcript of Record
(Plaintiff's Exhibits 1 to 32)

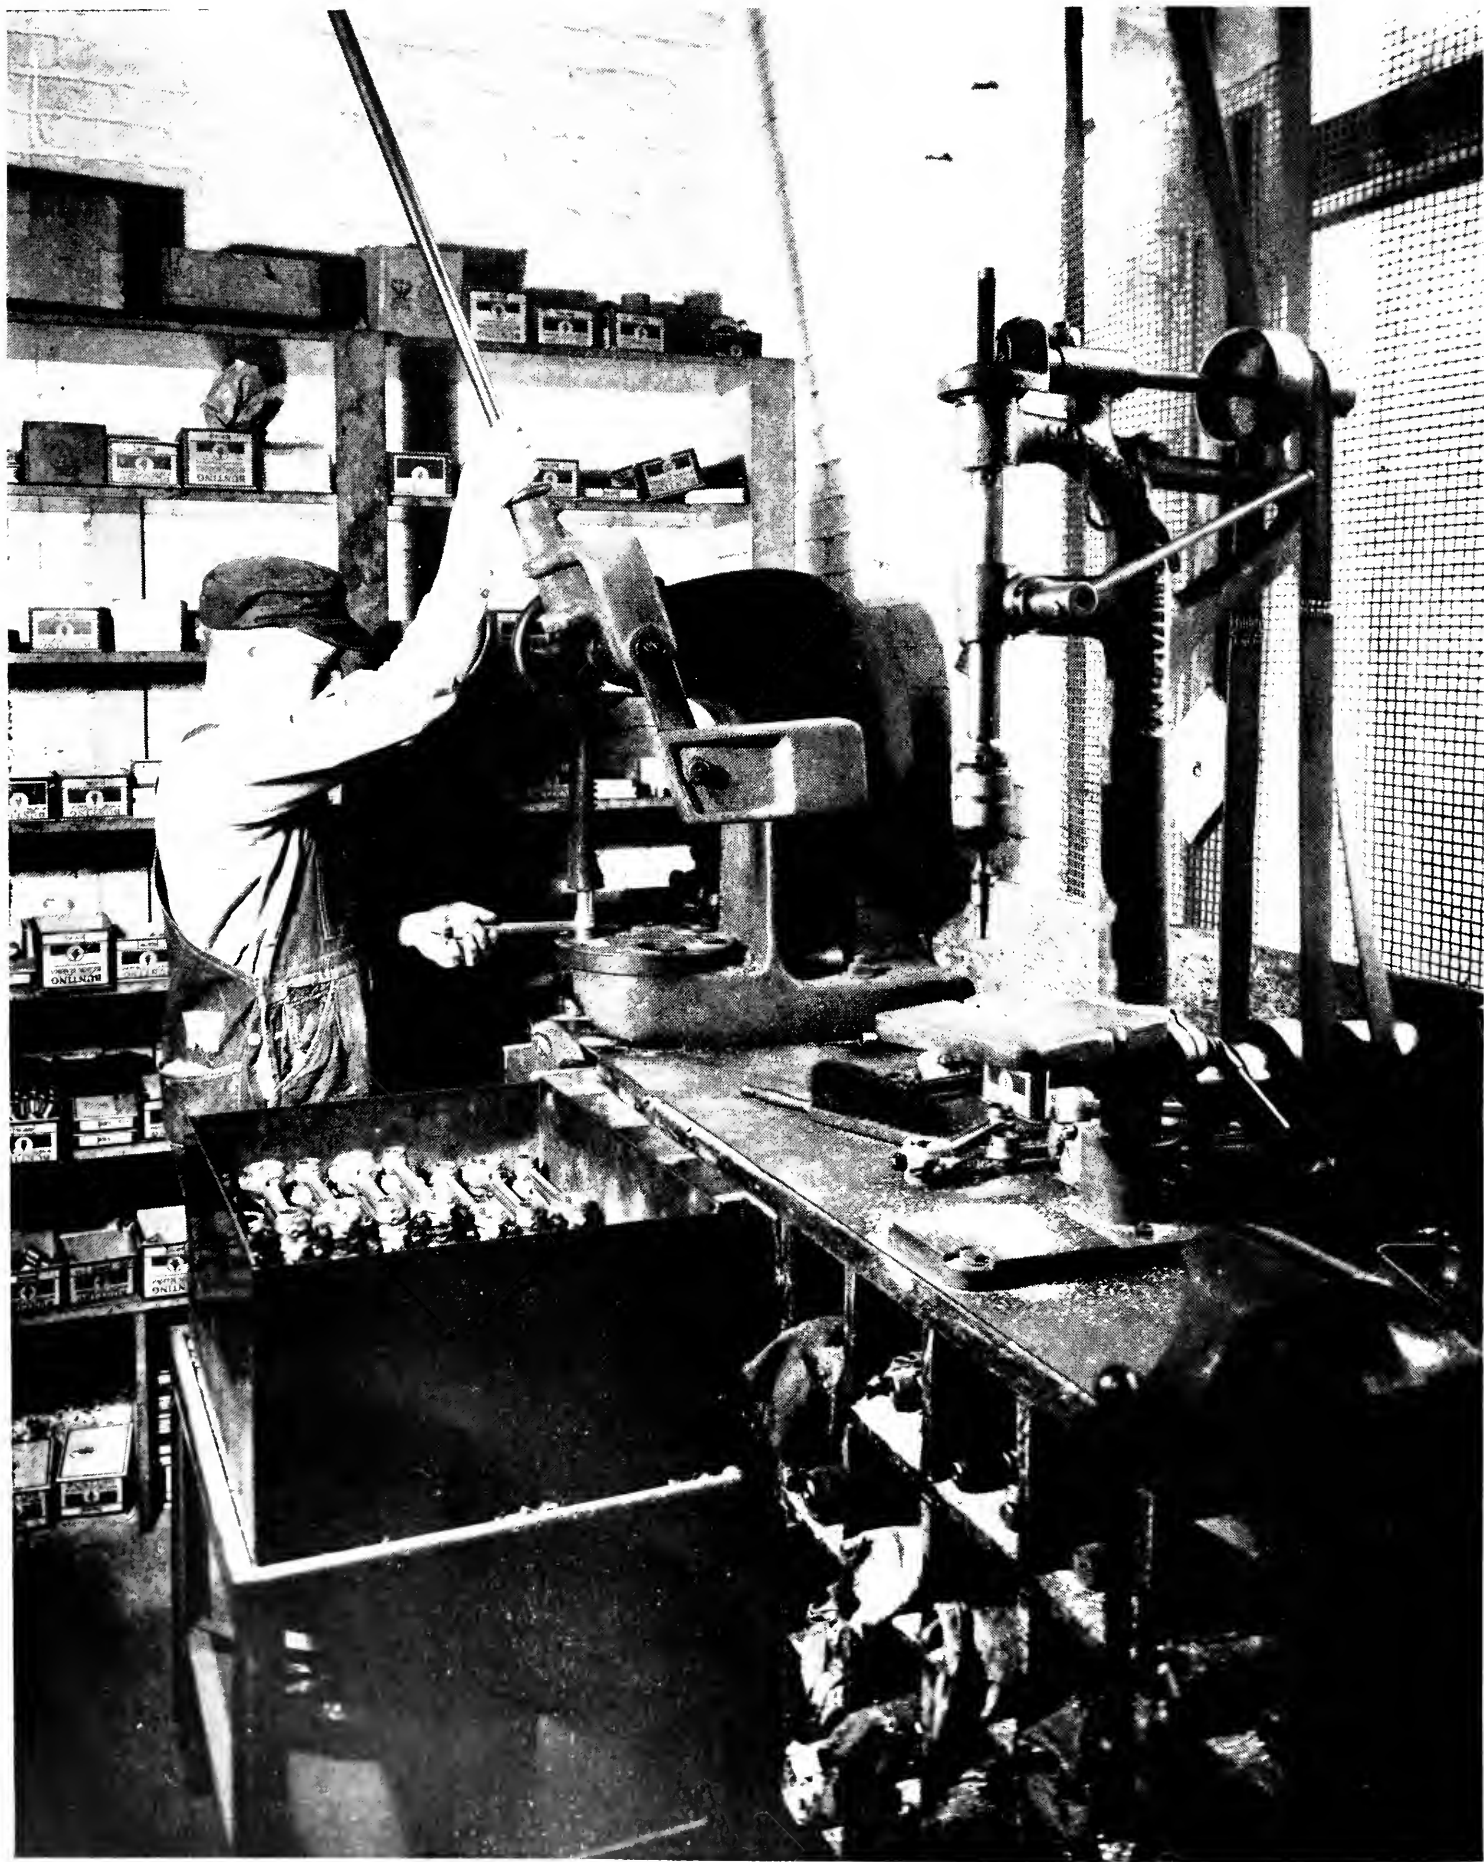
PLAINTIFF'S EXHIBIT No. 26

About one half of the connecting rods rebabbitted require new bushings in small end of the shank. These are installed by a hand operated arbor press, as shown above.

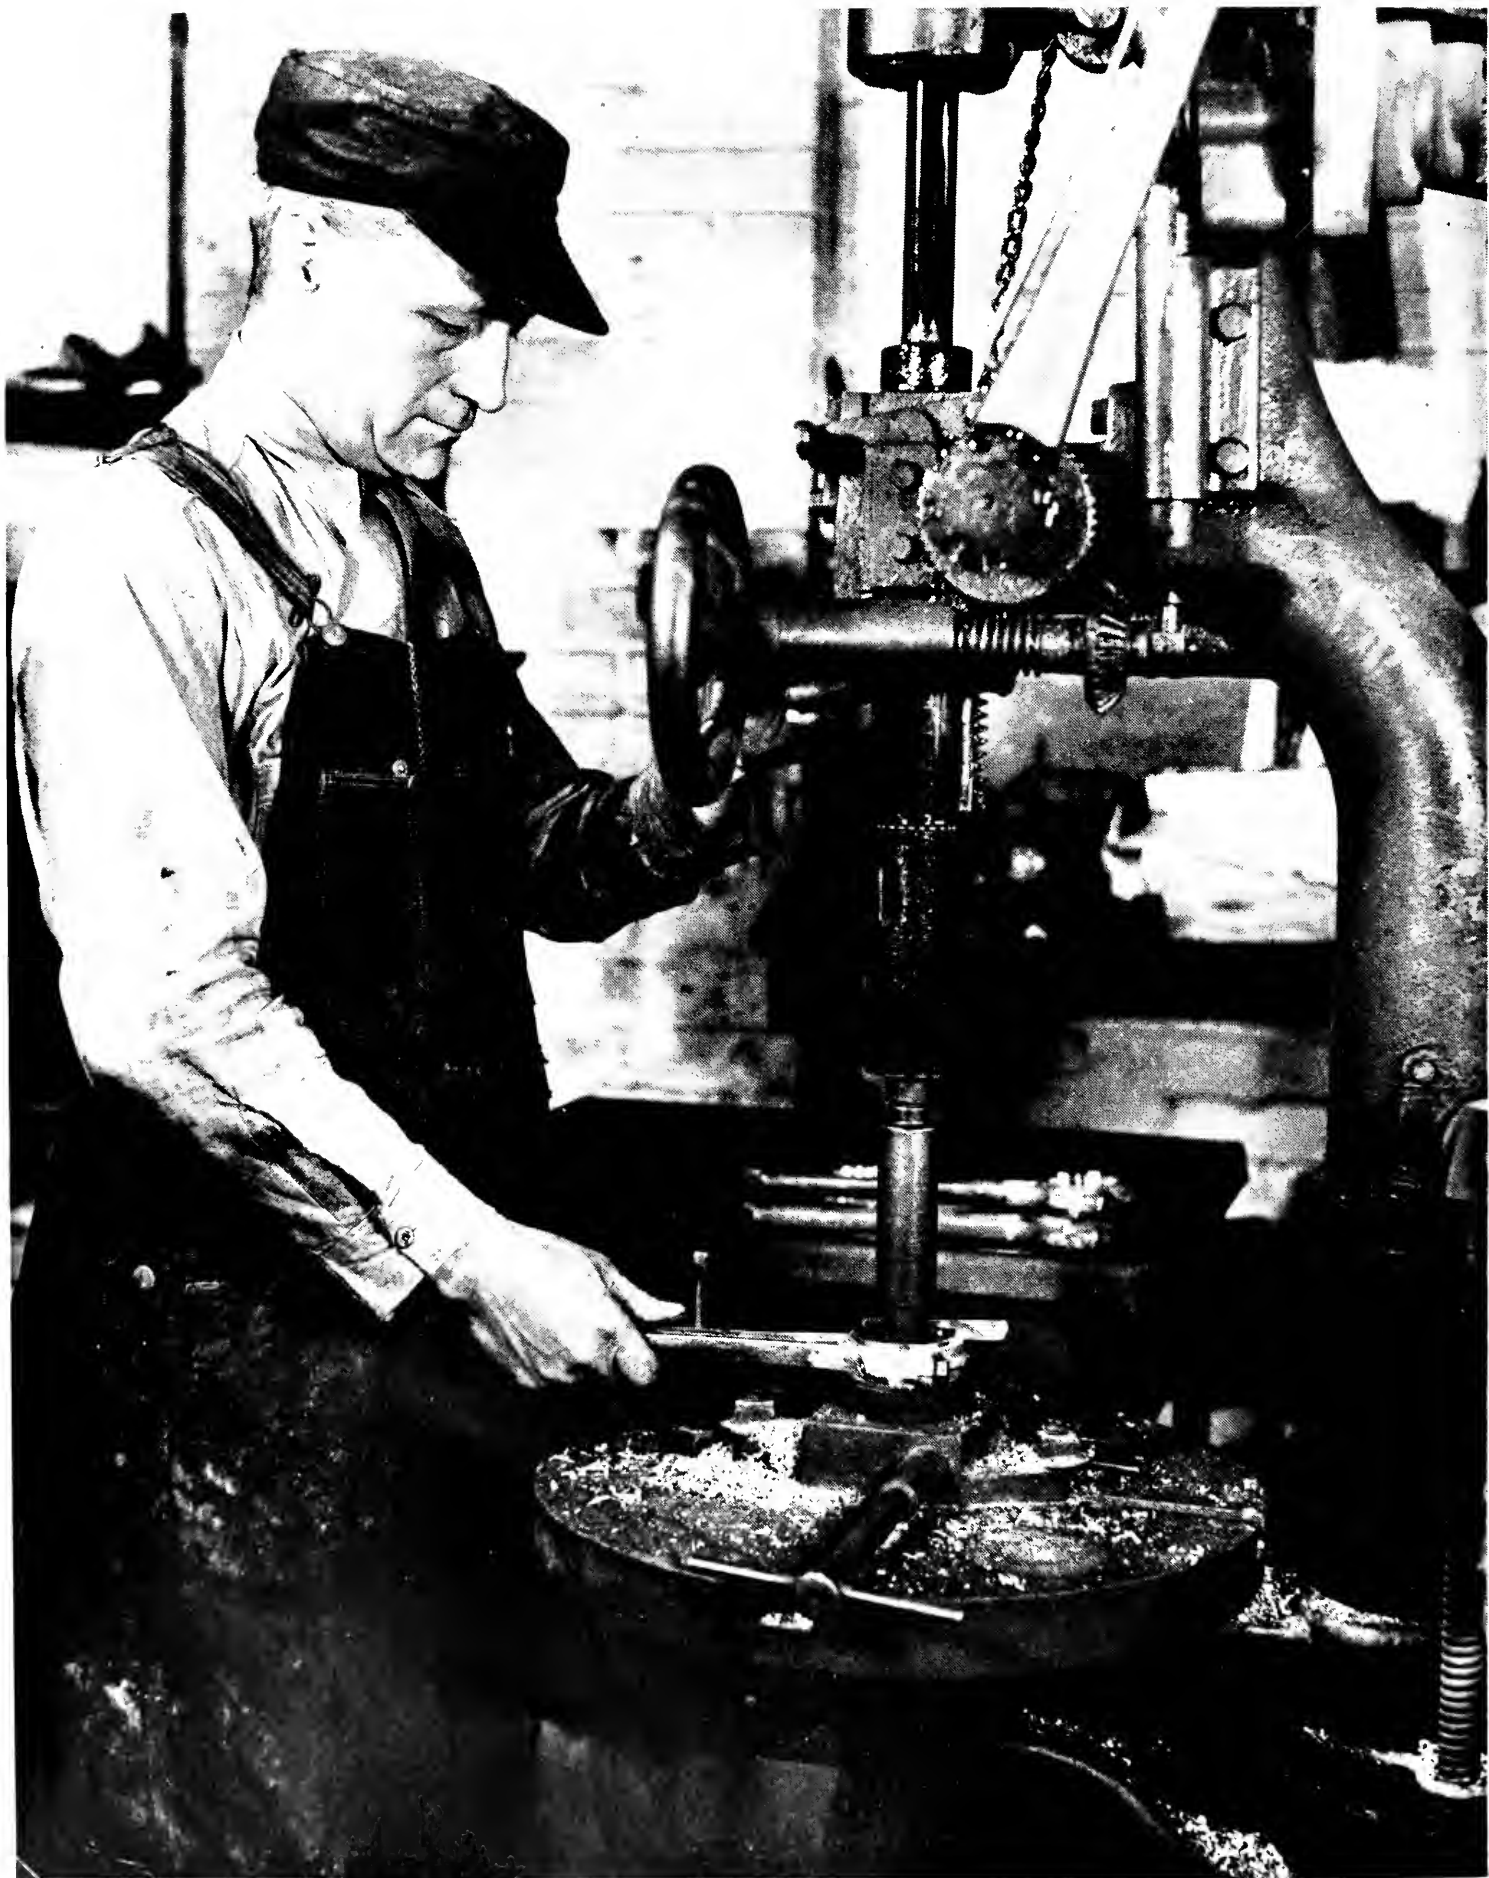
PLAINTIFF'S EXHIBIT No. 27

The outer edge of the babbitt flange is now faced by a special tool placed in a drill press. Approximately 50% of the rods rebabbitted were of a type that required this operation, which is shown in the above picture.

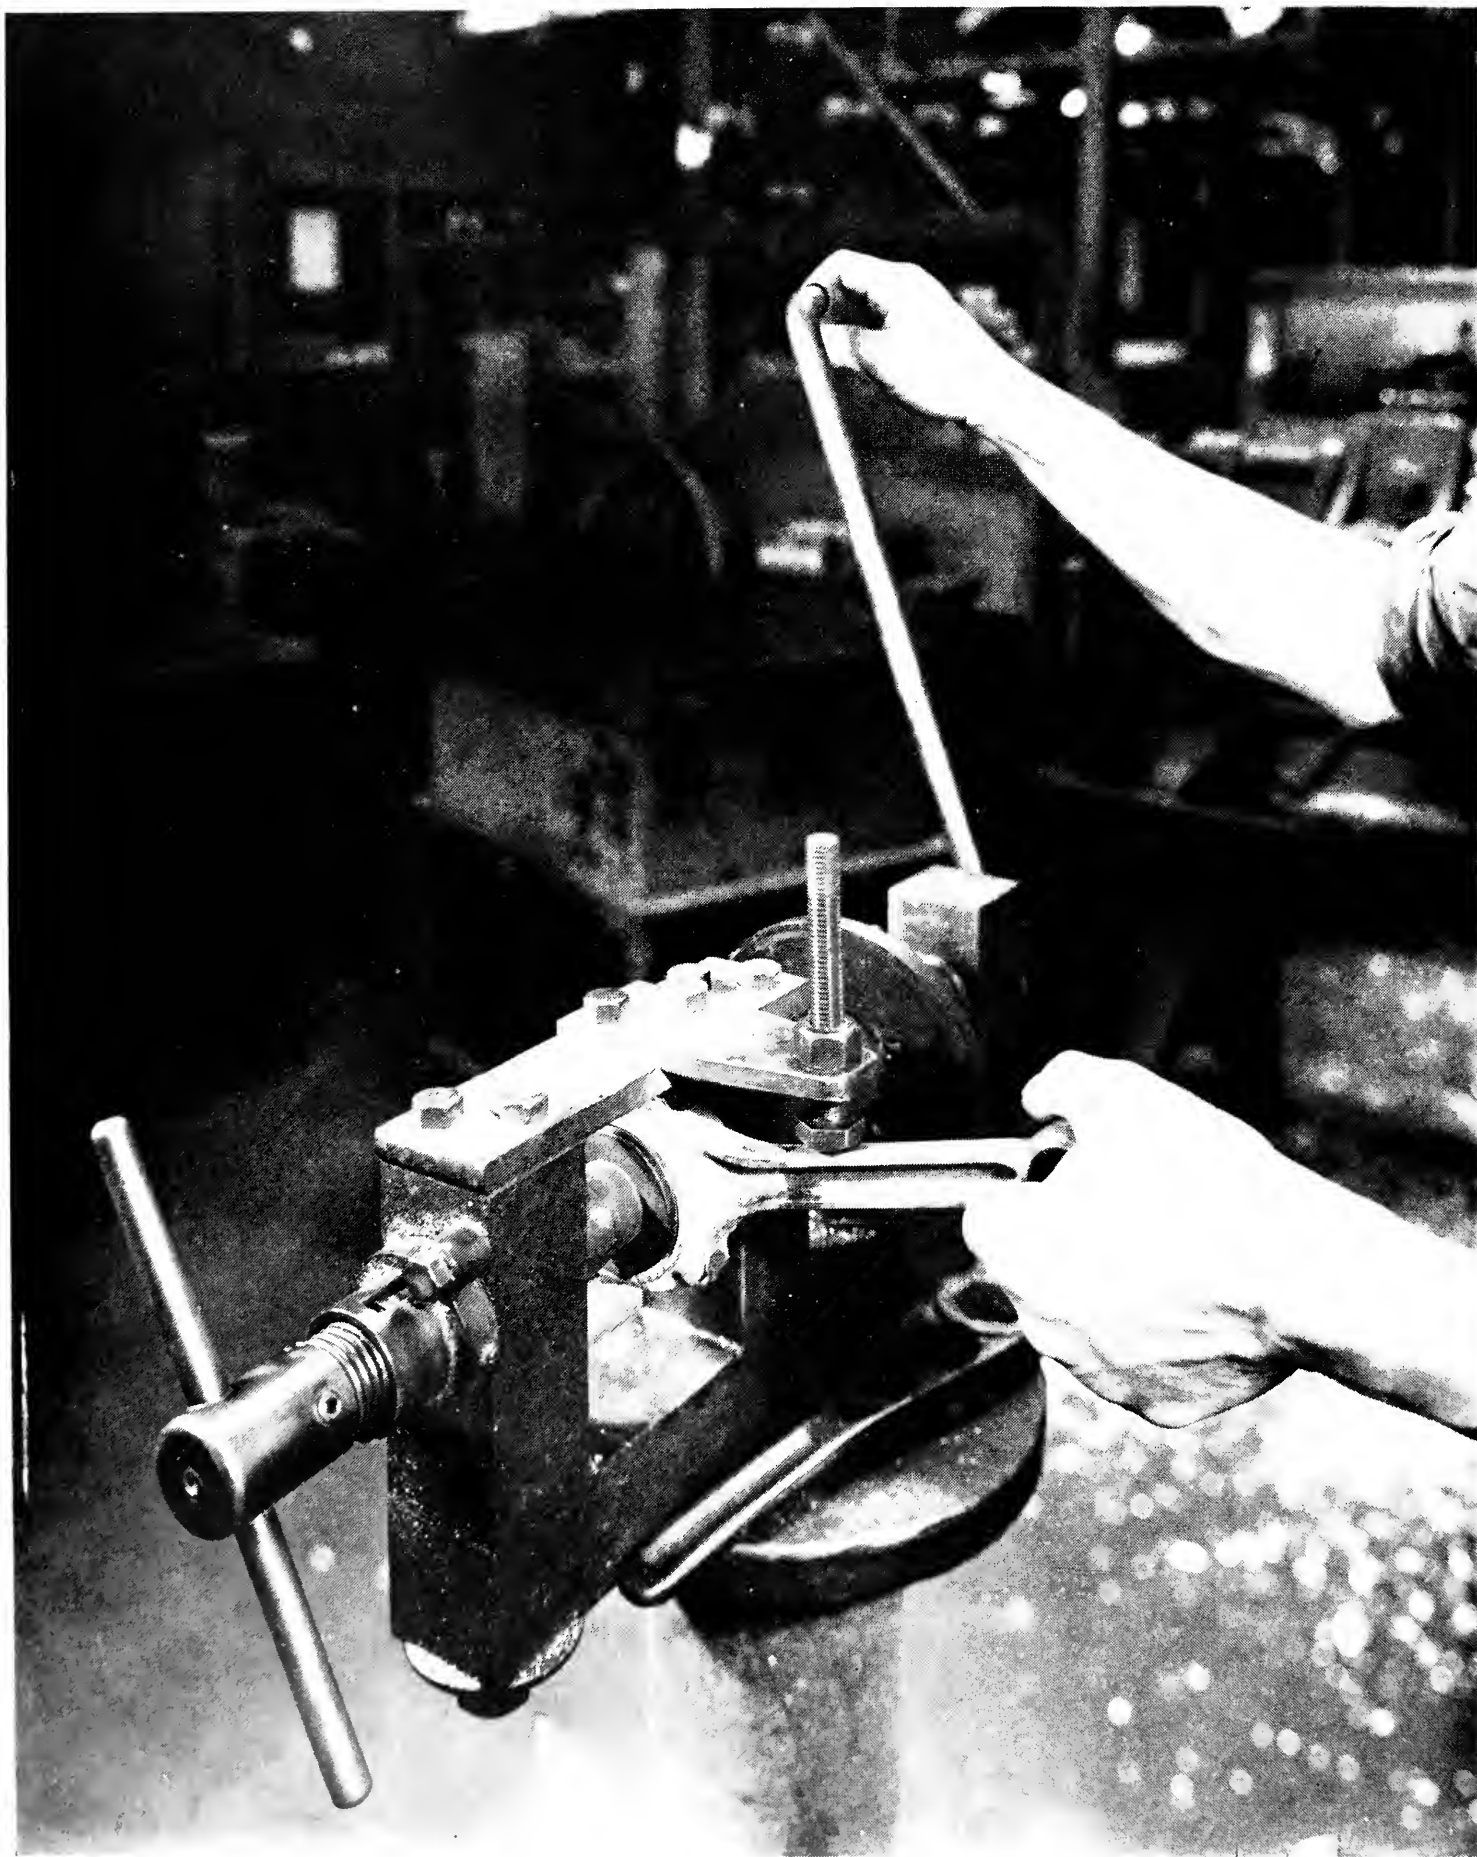
PLAINTIFF'S EXHIBIT No. 28

All Model A Ford and six-cylinder Chevrolet rebabbitted connecting rods require an oil groove on the face of the bearing which is cut in the shape of a figure 8 by hand operated oil groover as shown in the above picture.

All Model A Ford and six-cylinder Chevrolet rebabbitted connecting rods require an oil groove on the face of the bearing which is cut in the shape of a figure 8 by hand operated oil groover as shown in the above picture.

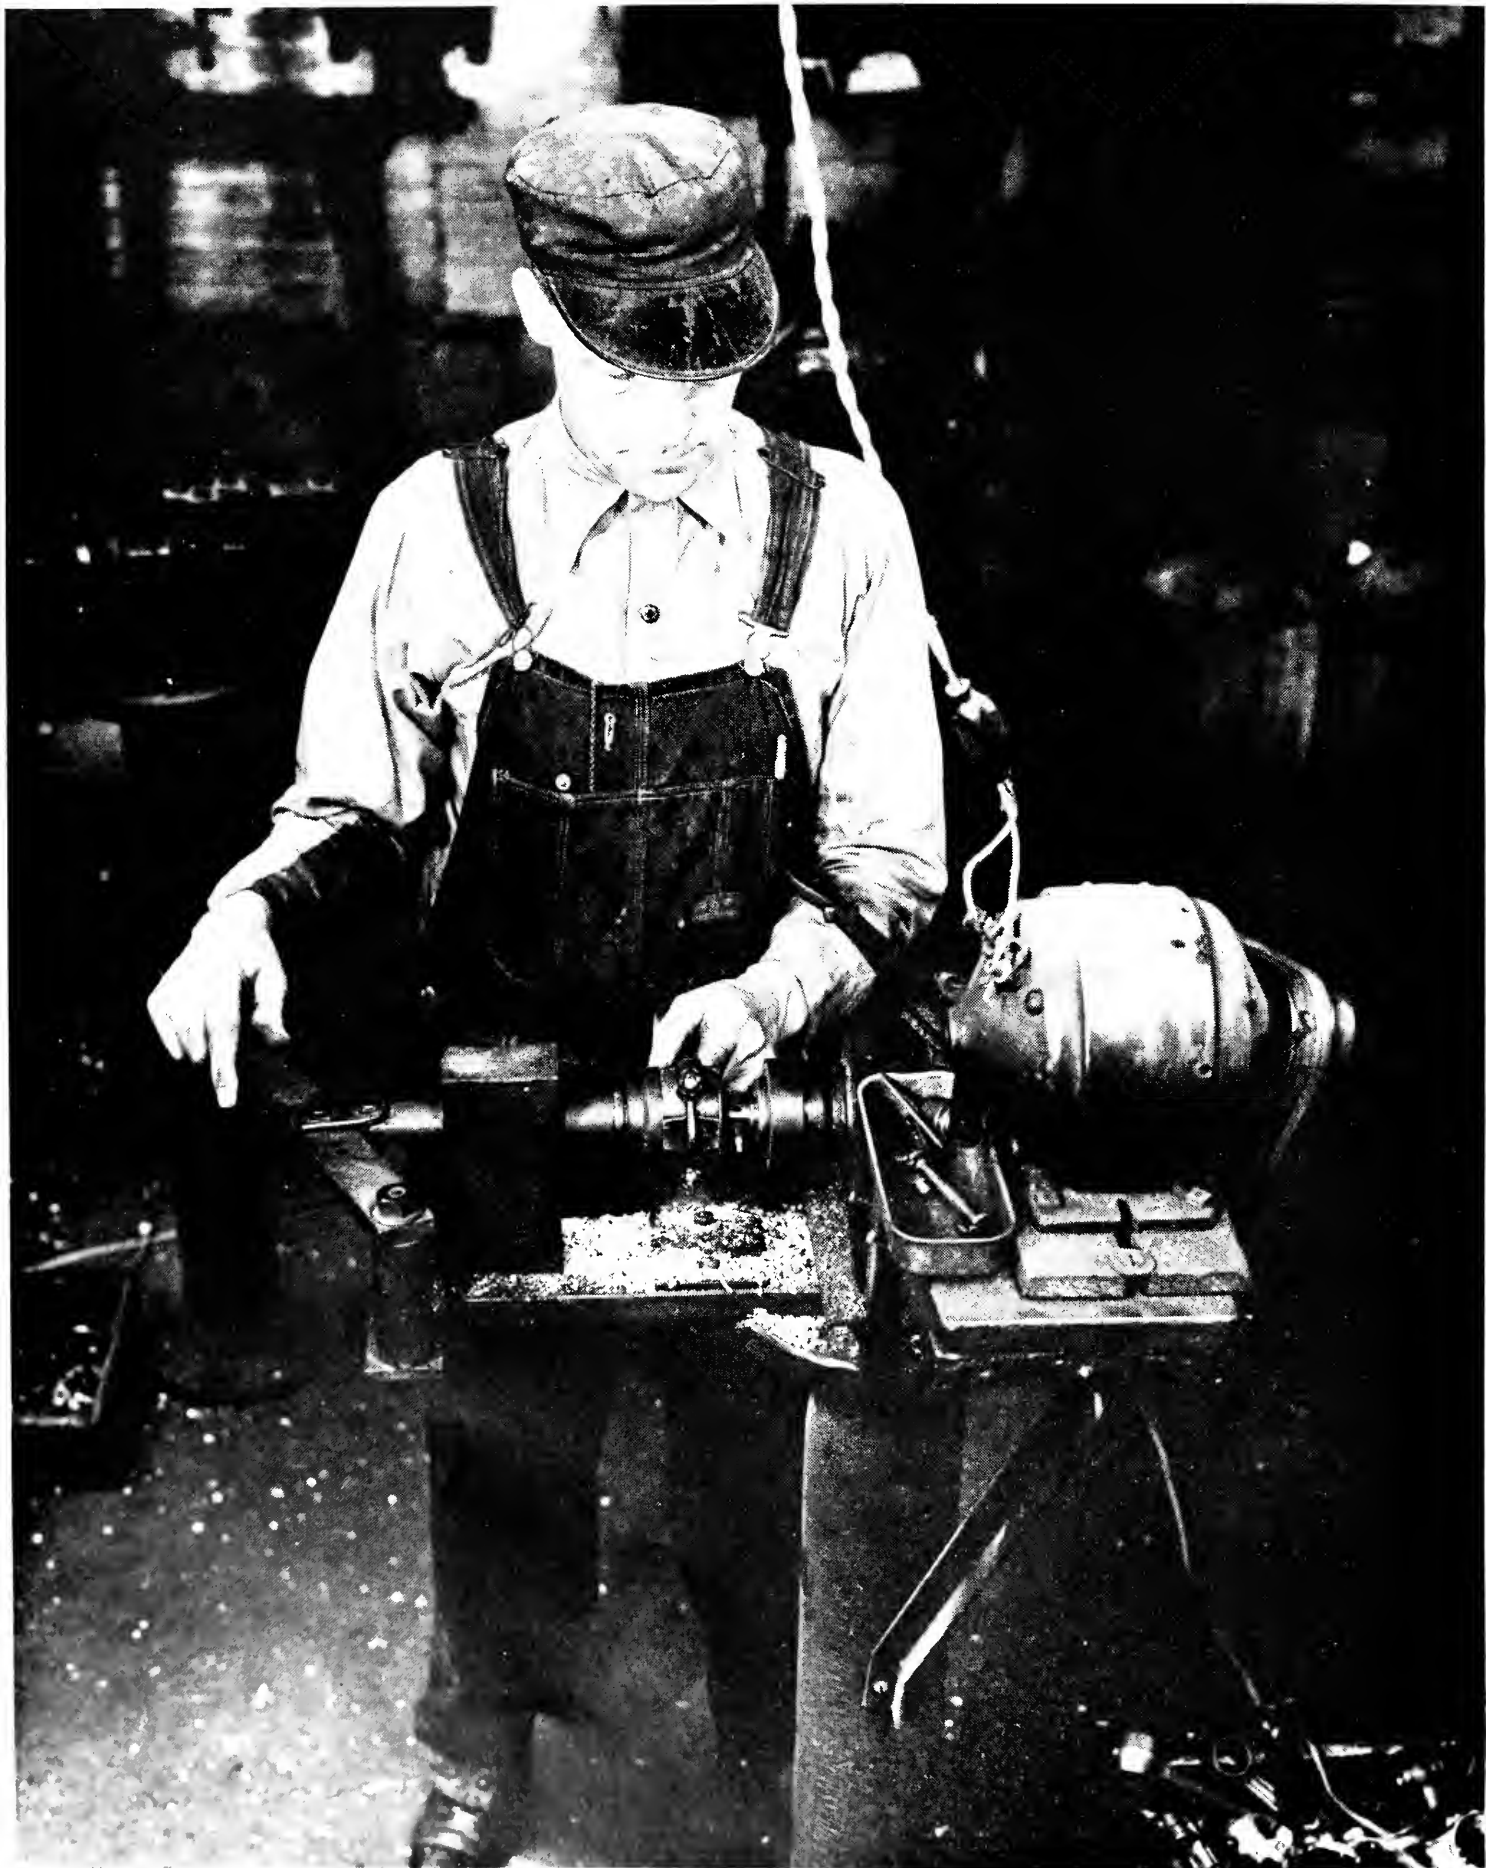
PLAINTIFF'S EXHIBIT No. 29

Certain Pontiac bearings require a continuous oil groove around the center, which is cut by the center oil groover shown in the above picture.

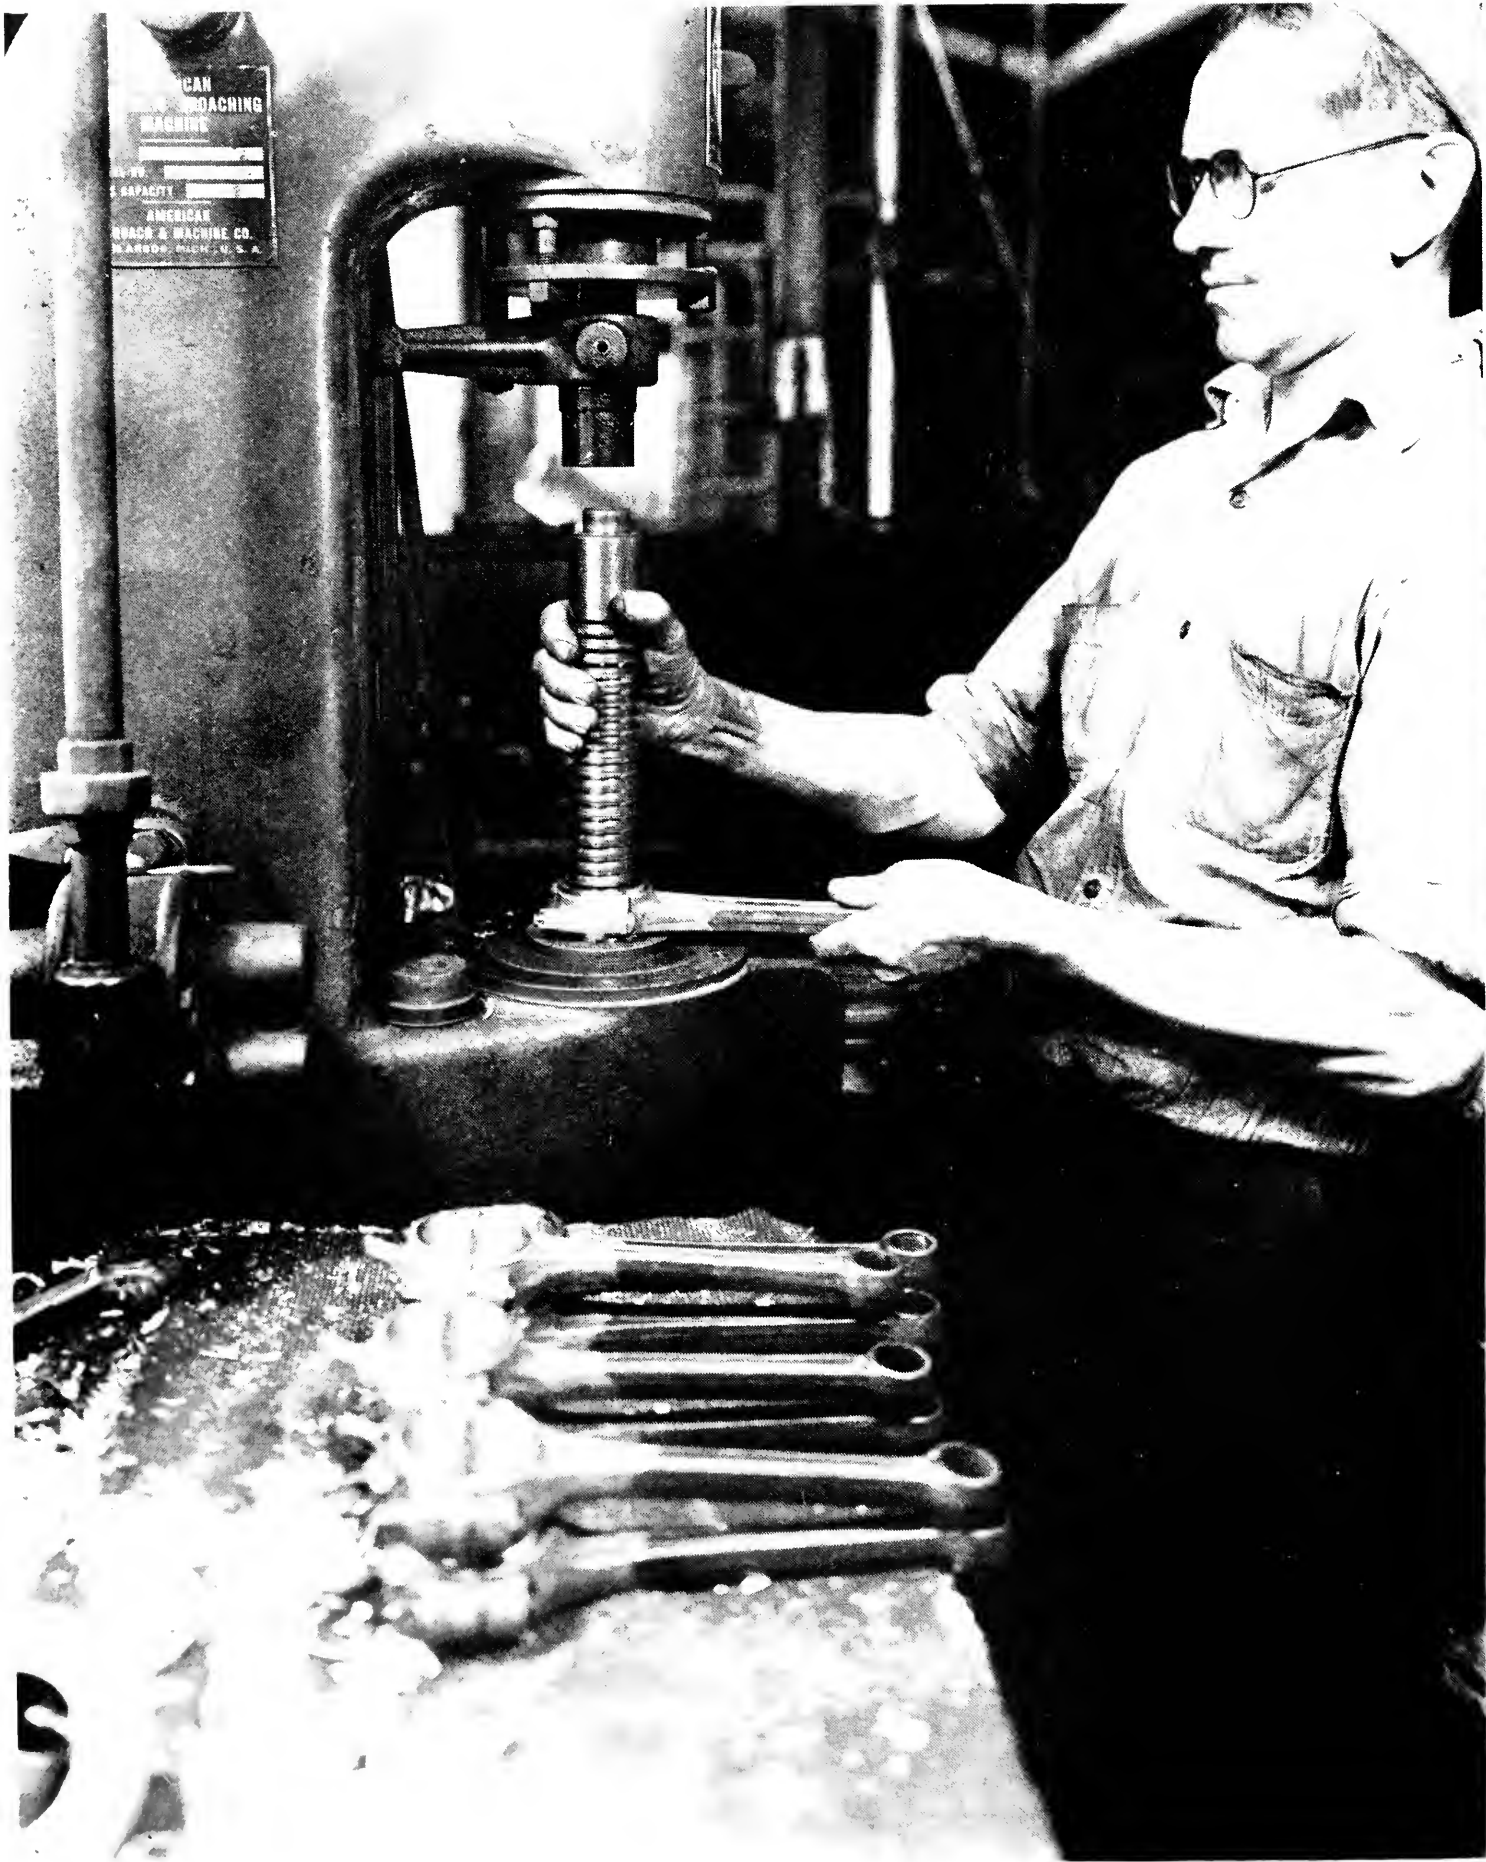
PLAINTIFF'S EXHIBIT No. 30

All babbitt bearings except the twenty per cent which are finished to special undersize on the lathe shown in Picture 22 are now finished to size by a hydraulically operated broaching machine as shown in the above picture. The broaching tool which is used for this operation is held in the workman's right hand. It is composed of a number of horizontal cutters each of which removes about .0005 as the tool is forced through the bearing by the hydraulic pressure.

All babbitt bearings except the twenty per cent which are finished to special undersize on the lathe shown in Picture 22 are now finished to size by a hydraulically operated broaching machine as shown in the above picture. The broaching tool which is used for this operation is held in the workman's right hand. It is composed of a number of horizontal cutters each of which removes about .0005 as the tool is forced through the bearing by the hydraulic pressure.

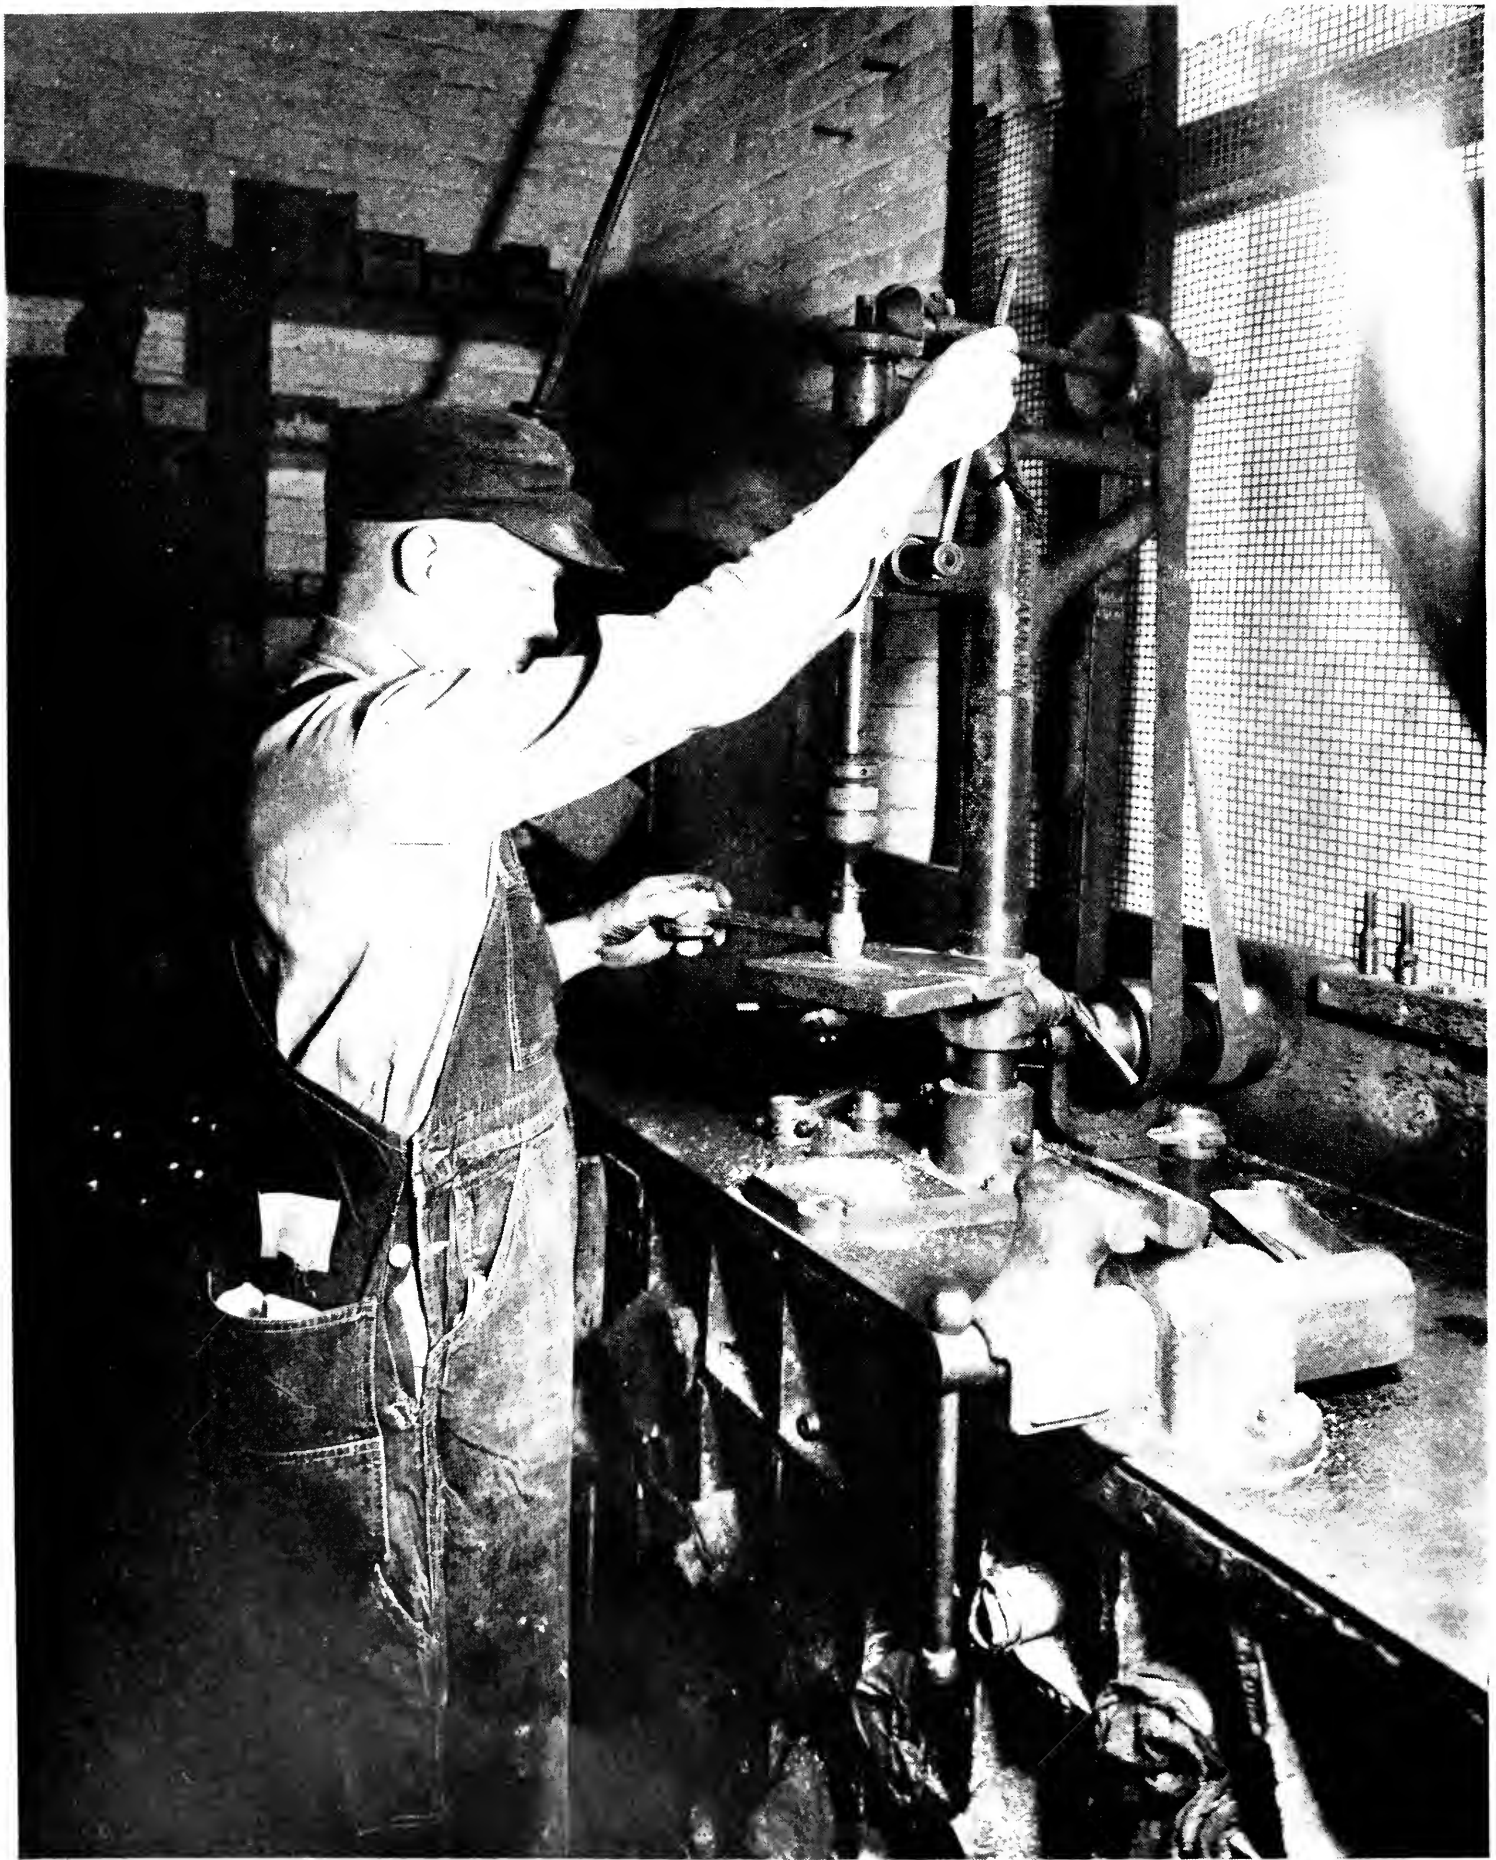
PLAINTIFF'S EXHIBIT No. 31

Model A Ford connecting rods are fitted with a very thin bushing which becomes somewhat damaged and burred when being pressed in by the arbor press shown in Picture 26. This is corrected by placing the connecting rods in a bench drill press in which a chamfering tool is used as shown in the above picture.

Model A Ford connecting rods are fitted with a very thin bushing which becomes somewhat damaged and burred when being pressed in by the arbor press shown in Picture 26. This is corrected by placing the connecting rods in a bench drill press in which a chamfering tool is used as shown in the above picture.

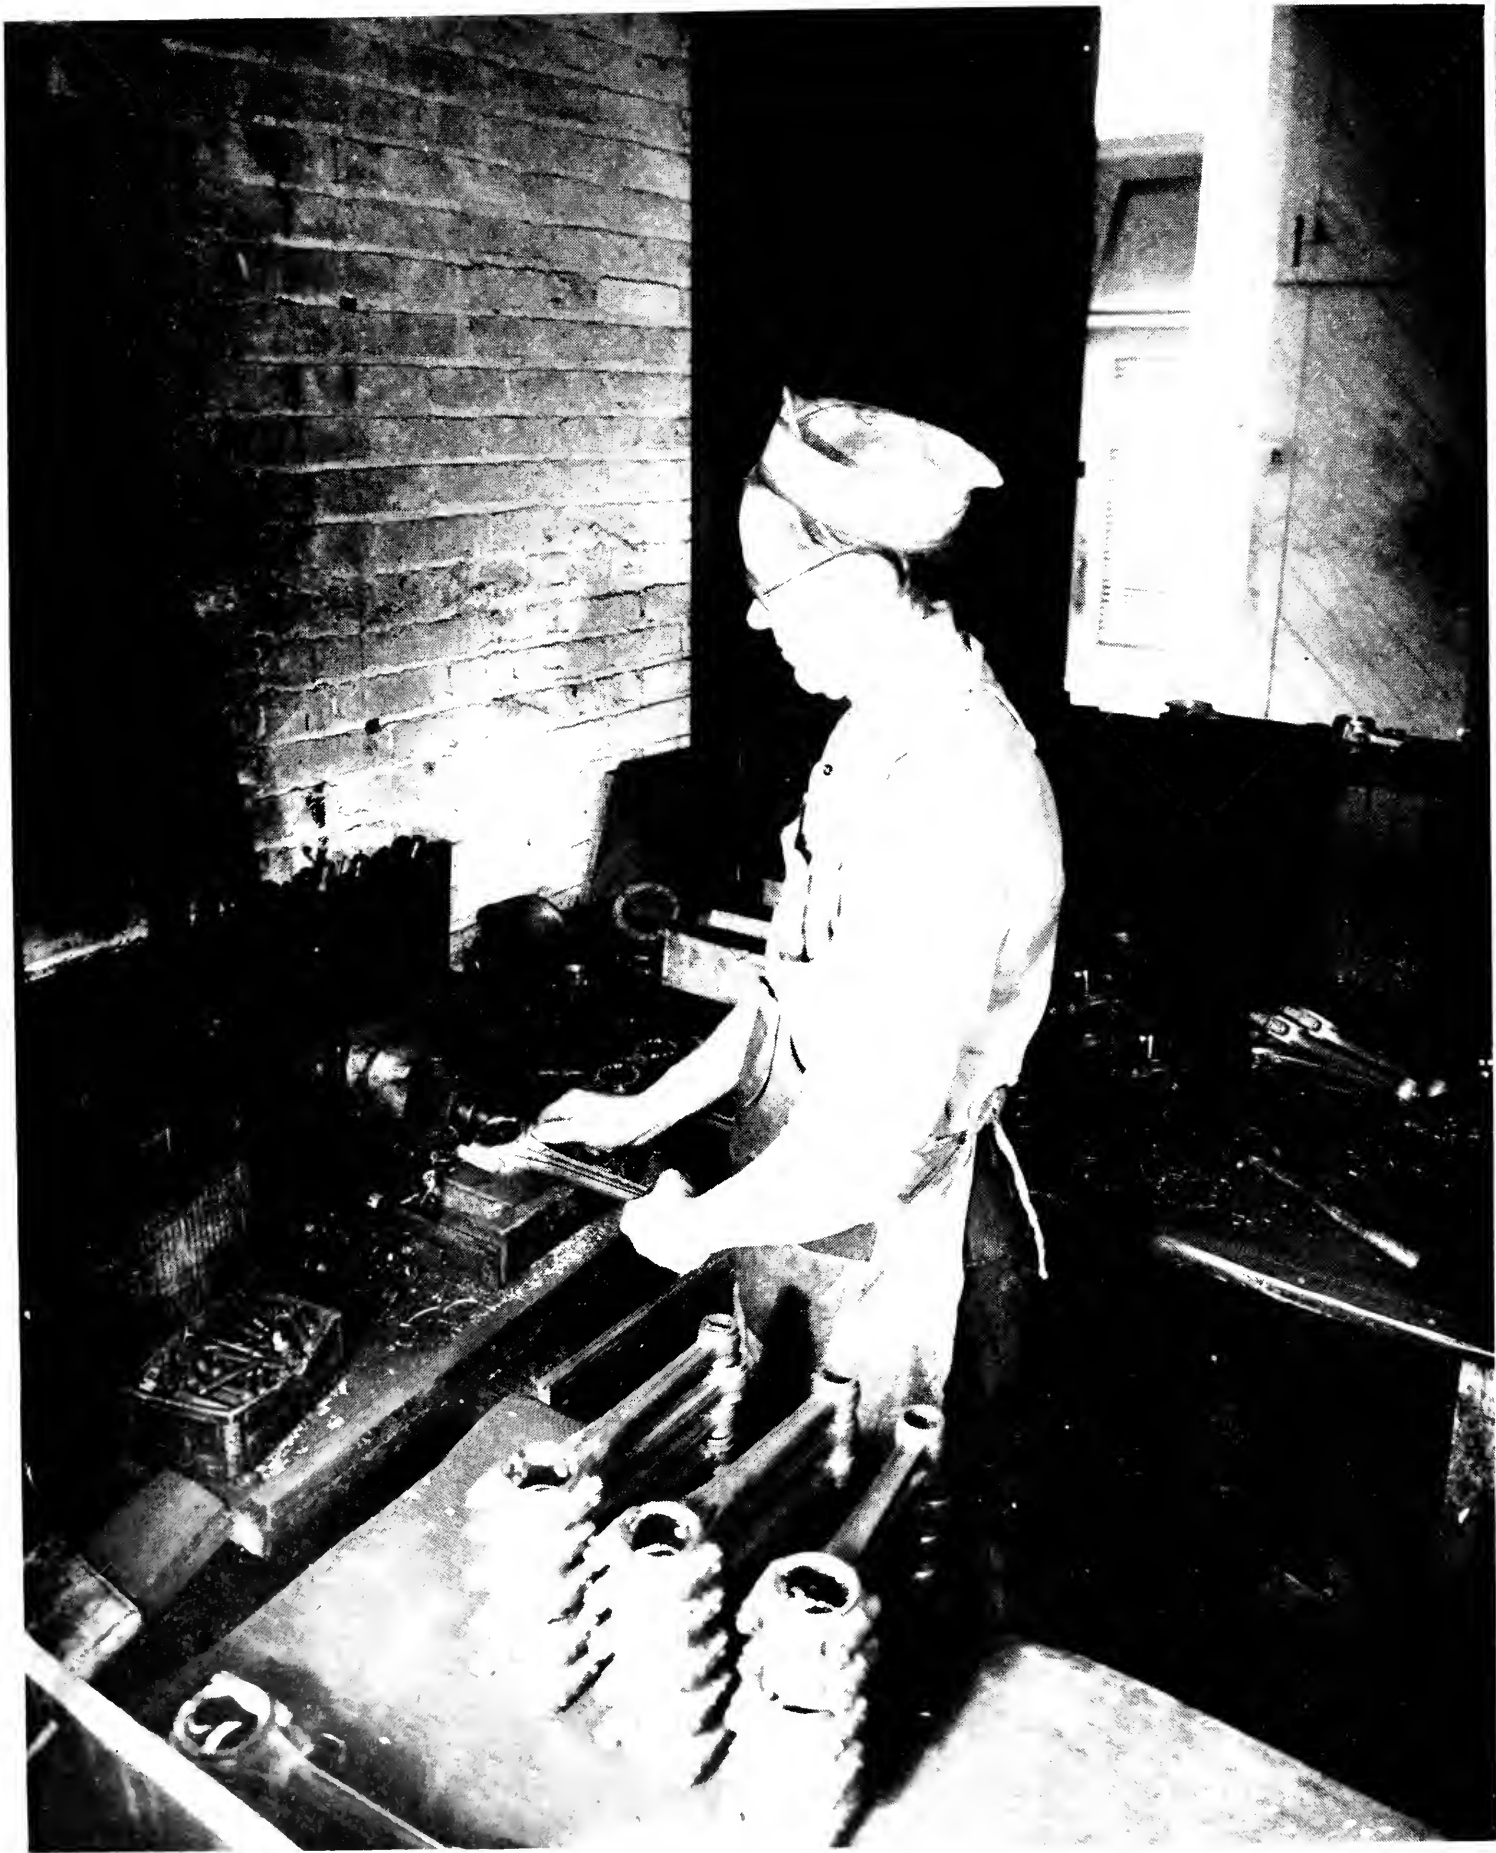
PLAINTIFF'S EXHIBIT No. 32

All connecting rod bearings are now given a final inspection and the nuts holding the connecting rod caps in place are loosened to enable the workman to make certain that the bolt or stud threads have not been stripped. The nuts are loosened by a power operated socket wrench as shown in the above picture.

All connecting rod bearings are now given a final inspection and the nuts holding the connecting rod caps in place are loosened to enable the workman to make certain that the bolt or stud threads have not been stripped. The nuts are loosened by a power operated socket wrench as shown in the above picture.
